The Wild Fish Conservancy (WFC) performed a spawning and redd survey on Joe's Creek in Federal Way, WA on March 12, 2008 (Fig.1). The objective of the survey was to evaluate this stream reach for the presence of adult steelhead or their redds and/or carcasses. A secondary objective was to characterize salmonid species composition within the survey reach.

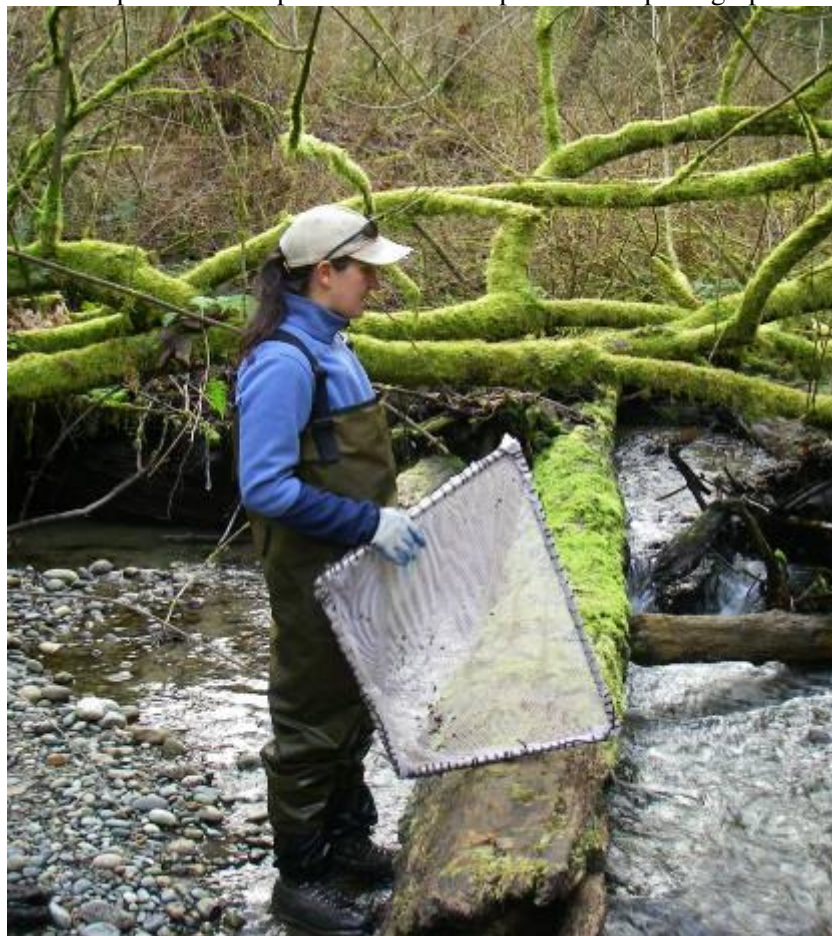
Fig.2. The Kinalovka trapezoidal fish collection net and typical high quality 3D habitat structure of Joe's Creek

The mainstem of Joe's Creek within the survey area contains high-quality fish rearing habitat including undercut banks and large in-stream woody debris (see Fig.2). Debris jams provide three dimensional structure within the channel which is important for the creation and maintenance of diverse instream habitats including scour pools, variable depths and velocities, channel braiding, and shallow fringe habitat. The substrate is composed primarily of gravel suitable for salmonid spawning with lateral habitats containing finer substrate. The mainstem channel within the study area had a wetted width of approximately 6-8 ft., and a bankfull width of 10-12 ft. At the stream flow stage observed at the time of the survey, passage of large fish such as steelhead between deeper pools may be difficult due to very shallow riffles; however during freshets it is likely that larger bodied salmonids could easily navigate the reach. No obvious structural barriers to fish passage were observed below the Twin Lakes golf course where large introduced cobble, high gradient, and an impassible water transfer structure prevent upstream fish movement (Fig.6.A-C). No fish were captured beyond the point where the stream passes the golf course (Fig.6.A) and is pumped underground (Fig.6.B).

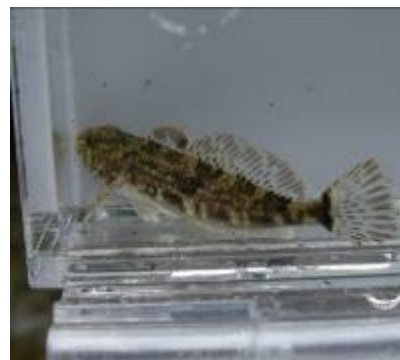
Three fish species were observed during the survey: *O. clarki clarki* (coastal cutthroat trout) were observed throughout the reach, *O. kisutch* (coho salmon) fry were observed in a localized area mid-reach and one sculpin (*Scorpaeniformes* sp.) was found near the mouth (Fig.3).

Fig.3. Joe's Creek spiny sculpin

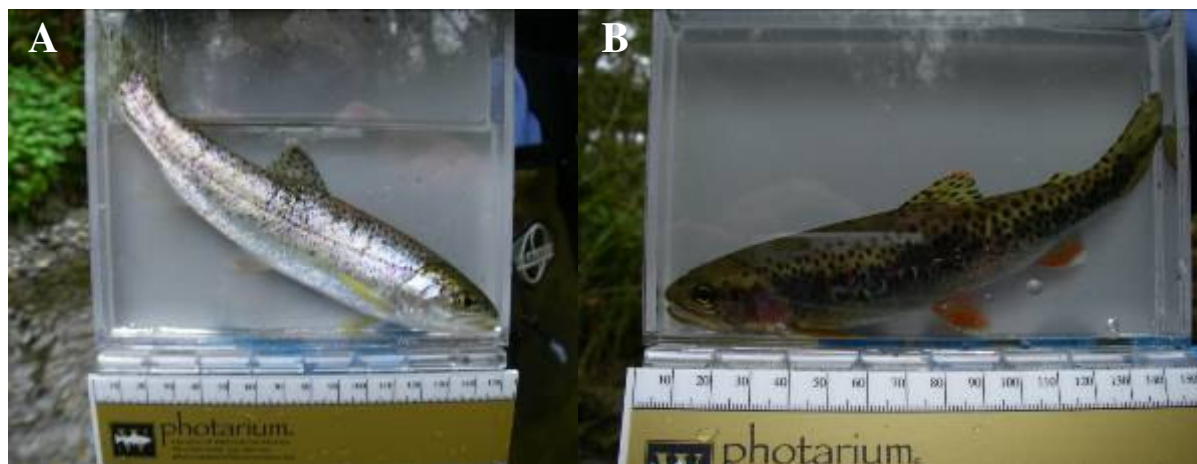
A total of 30 juvenile cutthroat trout were captured ranging in size from 80 to 200mm, apparently belonging to two age classes. Several larger cutthroats captured in the lowest reach of Joe's Creek appeared to be smolts, or in the process of smolting as their coloration was very silver (Fig. 4a) compared to most of the cutthroats captured (Fig.4b). Approximately half way up the reach (river mile 0.5) we captured approximately 40 young of the year coho salmon (Fig. 5) ranging from 28 to 32mm and observed a total of about 100 more coho fry using shallow water sheltered habitats. All fish captured had intact adipose fins, indicating that they were likely of natural (non-hatchery) origin. No coho were found above or below the 100m sub-reach in which the first group were found. No rainbow trout or steelhead were observed in the study reach.

Fig.4.A Silver colored cutthroat “smolt” (~180mm) and **(B)** in-stream colored “resident” (~160mm) captured in the same lower 500meters of Joes Creek on March 12, 2008

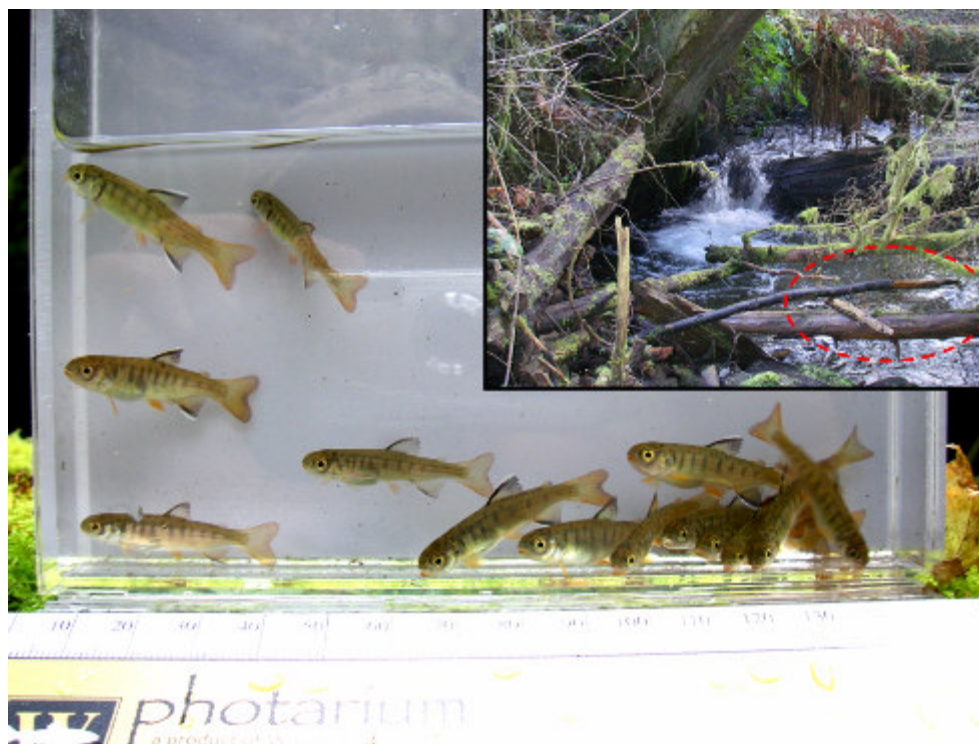
Fig.5. Coho salmon fry found at river mile 0.5 of Joe's Creek. Red ellipse on inset shows typical shallow fringe habitat where coho fry were found on the survey date.

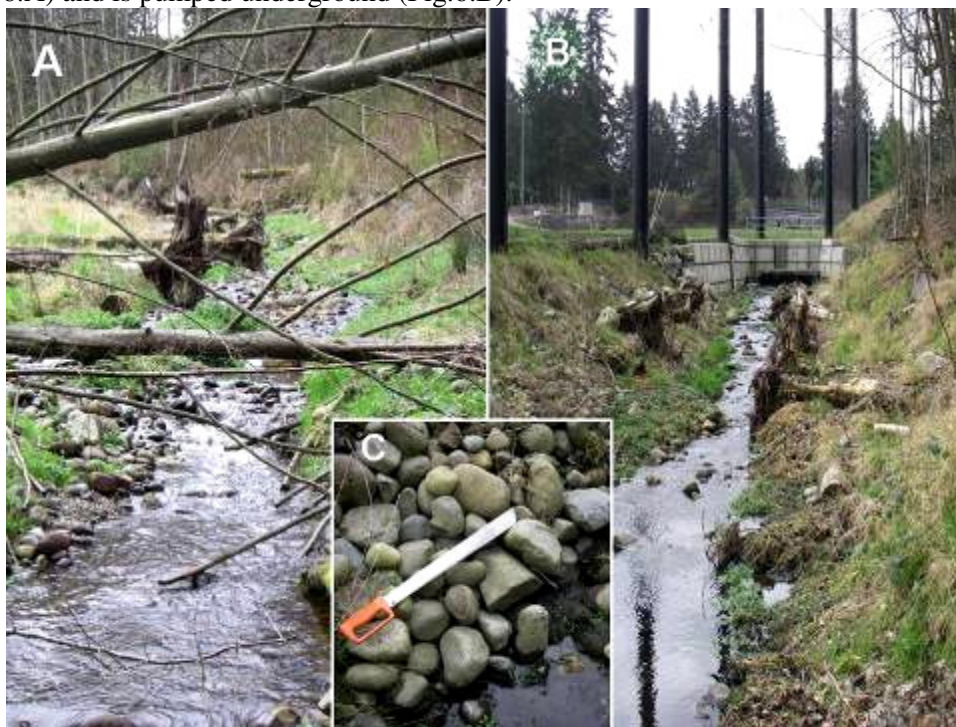
Fig.6.A Open canopy restoration area near Twin Lakes golf course and **(B)** stem pipe that moves water under the driving range. **Fig.6.C** is provided as a reference for the cobble-sized substrate introduced to Joe's creek by the restoration project shown in Fig.6.A and B.
